**Flood Control Project Maintenance
Levee Inspections**
LMA District Cover Sheet
Spring 2016 Levee Inspection Results

Reclamation District No. 2058 Pescadero

Levee Inspection Report By Mile - Spring 2016

Waterway	Bank	Unit Miles	Inspection Start/End	Inspector
Unit No. 01 Paradise Cut	Left	6.58	03/22/2016 03/22/2016	Maksim Khashchuk

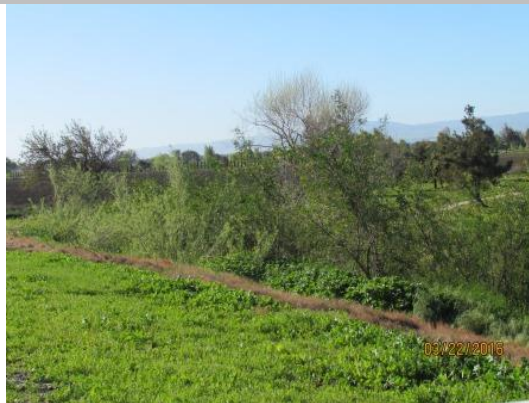
Photo 1 of 1 : SP_2016_RD2058_111_21_20160324_00039.jpg

LM Start	0.41	Rating **	M	Issue No.	21
LM End	0.45	Issue Type +	Ma	Location *	LS
Category	Earthen Levee			GPS Latitude/Longitude	
				Start	End
Item	Vegetation			37.803799 °	37.803436 °
				-121.415675 °	-121.415283 °
DWR ID	DWR_RD2058_01_s_2016_21				
Comment Code					
V2 : Remove the wild growth other than native grasses from the levee slopes.					
Inspector Comment

View of the vegetation on the landside levee slope and toe.

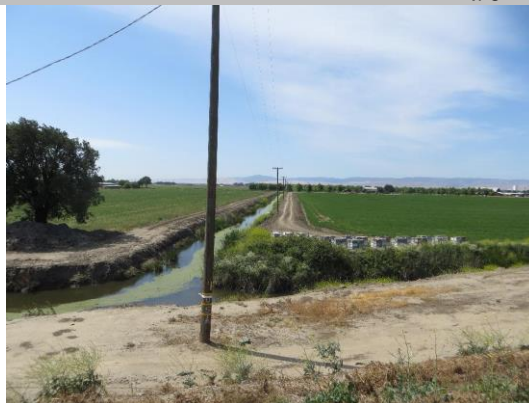
Photo 1 of 1 : UCIP_SP_2016_45847_74322.jpg

LM Start	1.21	Rating **	M	Issue No.	977
LM End	1.21	Issue Type +	En	Location *	LS
Category	Supplemental			GPS Latitude/Longitude	
				Start	End
Item	DWR UCIP Field Study			37.802249 °	37.802249 °
				-121.402183 °	-121.402183 °
DWR ID					
Comment Code					
Inspector Comment					
FS_ID:45847					
DS_ID:22693					
EP_NO: 10426					
Repair Type: Non-Urgent					
Crossing Status: Indicator Found					
UCIP Comments: Crossing needs to be marked.					
FIELD_STRUCT_DESC: 33-inch steel sewer pipe through levee 17.0					
feet below crown. Manholes visible along Delta Ave but no other					
indicators visible at levee (Permit No. 10426, 1975).					
FS Date: 5/12/2015

View of LS. Alignment of Crossing to right of canal at dirt access road.

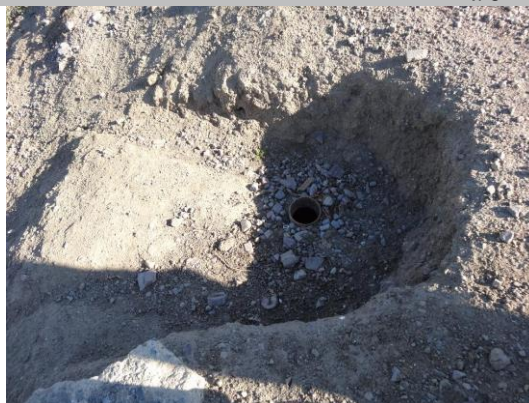
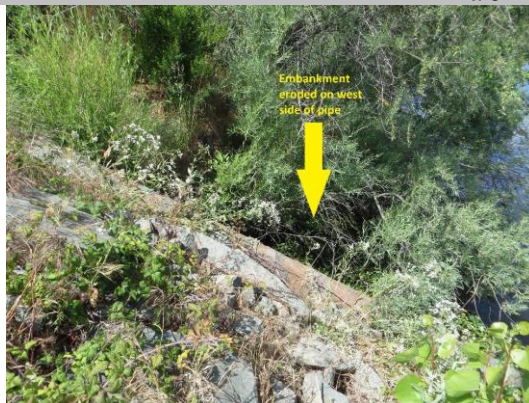
LM Start	1.22	Rating **	U	Issue No.	978
LM End	1.22	Issue Type +	En	Location *	LS
Category	Supplemental			GPS Latitude/Longitude	
				Start	End
Item	DWR UCIP Field Study			37.802301 °	37.802301 °
				-121.401977 °	-121.401977 °
DWR ID					
Comment Code					
Inspector Comment					
FS_ID:45850 DS_ID:22694 EP_NO: 11546 Repair Type: Urgent Crossing Status: Found UCIP Comments: Erosion on west side of pipe at W/S toe. FIELD_STRUCT_DESC: 18-inch steel stormdrain pipe through the levee 2-feet below the crown. Pump in ditch on the landward side. Siphon breaker on waterside shoulder. Electrical service pole at the landward toe. Permit No. 11546, 1976. FS Date: 5/13/2015

WS view: siphon breaker hole. Siphon breaker removed for repair.

WS view: slope on west side of pipe eroded at W/S toe. slope on east side of pipe OK.

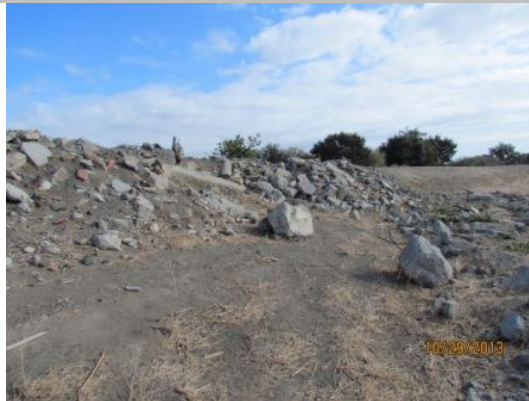
Photo 1 of 1 : SP_2016_RD2058_111_11_20160229_00005.jpg

LM Start	1.82	Rating **	U	Issue No.	11
LM End	1.82	Issue Type +	Ma	Location *	LS
Category	Earthen Levee			GPS Latitude/Longitude	
				Start	End
Item	Encroachments			37.804785 °	37.804785 °
				-121.391524 °	-121.391524 °
DWR ID	DWR_RD2058_01_f_2013_11				
Comment Code					
MA : Material					
Inspector Comment					
Pile of concrete contains rebar on landside slope obstructing visibility and access.

View of the concrete with rebar placed on the landside slope.

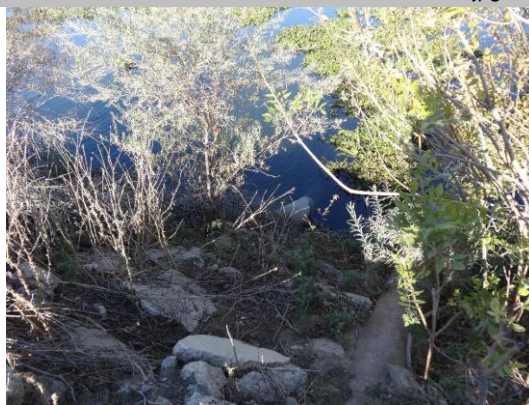
Photo 1 of 2 : UCIP_SP_2016_46770_45192.jpg

LM Start	2.12	Rating **	M	Issue No.	975
LM End	2.12	Issue Type +	En	Location *	LS
Category	Supplemental			GPS Latitude/Longitude	
				Start	End
Item	DWR UCIP Field Study			37.803886 °	37.803886 °
				-121.386271 °	-121.386271 °
DWR ID					
Comment Code					
Inspector Comment					
FS_ID:46770 DS_ID:22706 EP_NO: N/A Repair Type: Non-Urgent Crossing Status: Found UCIP Comments: Leaky and damaged siphon breaker on waterside shoulder. Update: leaky siphon breaker at LM 2.14 repaired per Spring 2015 Inspection Report. Need to confirm repair was done at this location. FIELD_STRUCT_DESC: 16-inch steel stormdrain pipe 8.0-feet below the crown. Siphon Breaker on waterward shoulder. Pump on concrete sump on landside. Originally included in the 1964 O&M manual, SJR 10, March 1964. FS Date: 5/13/2015

WS view: exposed steel pipe (right) on channel bank.

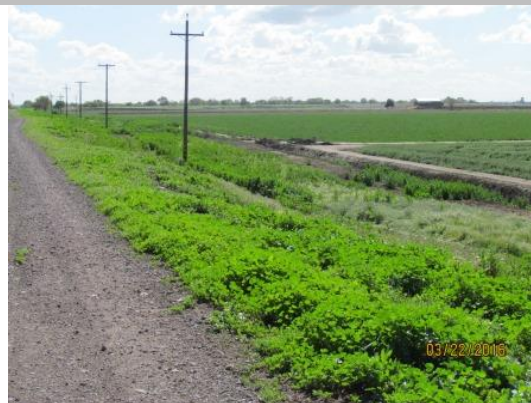
Photo 1 of 1 : SP_2016_RD2058_111_23_20160324_00040.jpg

LM Start	2.44	Rating **	M	Issue No.	23
LM End	2.71	Issue Type +	Ma	Location *	LS
Category	Earthen Levee			GPS Latitude/Longitude	
				Start	End
Item	Vegetation			37.802608 °	37.801509 °
				-121.380638 °	-121.375805 °
DWR ID	DWR_RD2058_01_s_2016_23				
Comment Code					
V1 : Control annual grass and weeds on the levee slopes and easements.					
Inspector Comment

View of the vegetation on the landside levee slope.

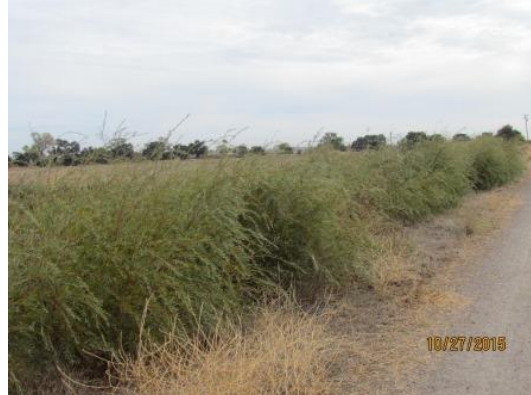
Photo 1 of 1 : SP_2016_RD2058_111_17_20160229_00008.jpg

LM Start	2.75	Rating **	A/W	Issue No.	17
LM End	2.75	Issue Type +	Ma	Location *	WS
Category	Earthen Levee			GPS Latitude/Longitude	
				Start	End
Item	Vegetation			37.801367 °	37.801367 °
				-121.375094 °	-121.375094 °
DWR ID	DWR_RD2058_01_f_2015_17				
Comment Code					
V2 : Remove the wild growth other than native grasses from the levee slopes.					
Inspector Comment					
LMA removed vegetation fall 2015.

View of the willows on the waterside levee slope.

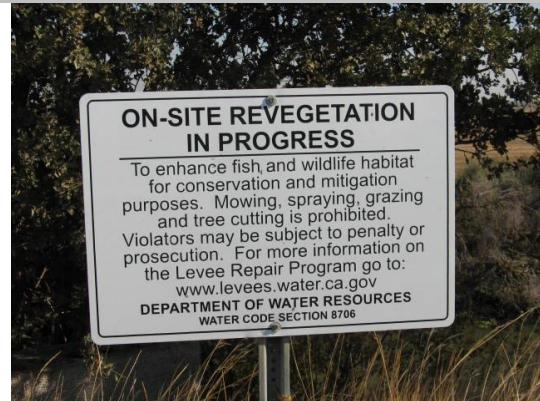
Photo 1 of 1 : SP_2016_RD2058_111_20_20160229_00010.jpg

LM Start	3.80	Rating **	A/W	Issue No.	20
LM End	3.85	Issue Type +	Ob	Location *	WS
Category	Earthen Levee			GPS Latitude/Longitude	
				Start	End
Item	Vegetation			37.790807 °	37.790088 °
				-121.362905 °	-121.362460 °
DWR ID	DWR_RD2058_01_s _ 2012_20				
Comment Code					
V8 : Environmental Requirements.					
Inspector Comment					
Revegetation site.

11/08/2011 Revegetation site, cannot trim or cut vegetation in this area.

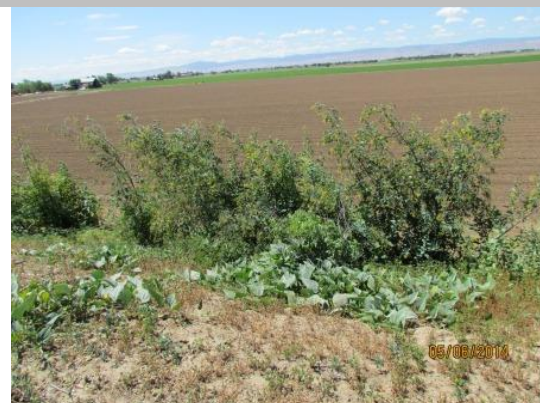
Photo 1 of 1 : SP_2016_RD2058_111_22_20160229_00011.jpg

LM Start	3.91	Rating **	A/W	Issue No.	22
LM End	3.91	Issue Type +	Ma	Location *	LS
Category	Earthen Levee			GPS Latitude/Longitude	
				Start	End
Item	Vegetation			37.789434 °	37.789434 °
				-121.361721 °	-121.361721 °
DWR ID	DWR_RD2058_01_s _ 2014_22				
Comment Code					
V2 : Remove the wild growth other than native grasses from the levee slopes.					
Inspector Comment					
LMA removed vegetation in Fall 2015.

View of the tall vegetation on the landside levee slope and toe.

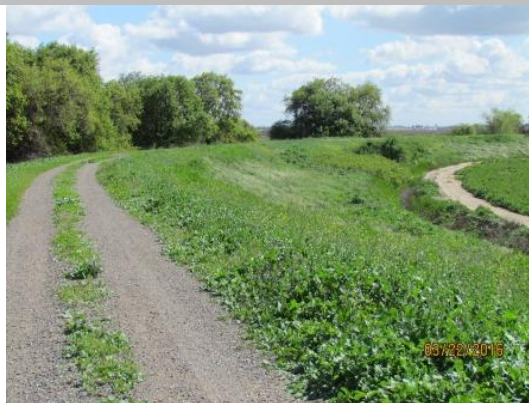
Photo 1 of 1 : SP_2016_RD2058_111_24_20160324_00041.jpg

LM Start	4.31	Rating **	M	Issue No.	24
LM End	5.58	Issue Type +	Ma	Location *	LS
Category	Earthen Levee			GPS Latitude/Longitude	
				Start	End
Item	Vegetation			37.789768 °	37.779132 °
				-121.354919 °	-121.339619 °
DWR ID	DWR_RD2058_01_s _ 2016_24				
Comment Code					
V1 : Control annual grass and weeds on the levee slopes and easements.					
Inspector Comment

View of the vegetation on the landside levee slope.

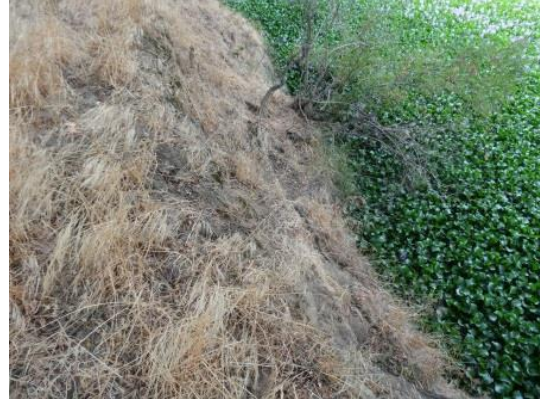
Photo 3 of 3 : SP_2016_RD2058_111_1_20160229_00003.jpg

Comment Code						
Inspector Comment						
08/04/2015: No significant change observed.						
08/26/2014: No significant change observed.						
08/28/2013: No significant change observed.						
07/26/2012: The site has been visited, and no significant change has been observed.						
09/02/2011: This site was not visited due to the time limit.						
09/22/2010: No significant change observed. Minor pocket erosions are lined at the lower bank. Two large Oak and Willow trees are on mid-slope and bench. The remaining bench was re-measured and found to be approximately 10 feet. There was no indication of active erosion on site during the site visit.						
08/05/2010: Recommended for annual assessment and monitoring of the site during flood events, per CLRO.						
07/23/2009: No major change observed since last visit; site is a 200-ft. long near-vertical berm erosion; recommend annual assessment and monitoring of the erosion site, per CLRO CES Evaluation 2008 Report; Site # is the same site previously reported as RM4.0,LM4.51; previously rated "U".

09/10/2008: Two large trees (2-3' DBH) with partial roots exposed.						
2007: Visited site 03/13/2007. [2015 Site ID:RD2058U01RM3.97]

Direct view of a pocket erosion site.

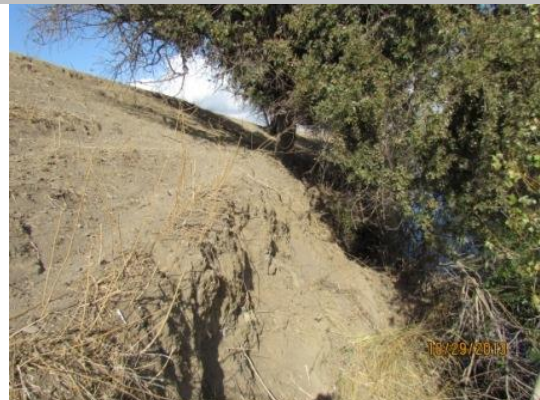
Photo 1 of 1 : SP_2016_RD2058_111_15_20160229_00007.jpg

LM Start	4.77	Rating **	U	Issue No.	15
LM End	4.77	Issue Type +	Ma	Location *	WS
Category	Earthen Levee			GPS Latitude/Longitude	
				Start	End
Item	Erosion / Bank Caving			37.785862 °	37.785862 °
				-121.350303 °	-121.350303 °
DWR ID	DWR_RD2058_01_f_2013_15				
Comment Code					
E1 : Note and monitor erosion site.					
Inspector Comment					
The erosion has about a 3 foot vertical cut at the waterside levee toe.

View of the erosion at the waterside levee toe.

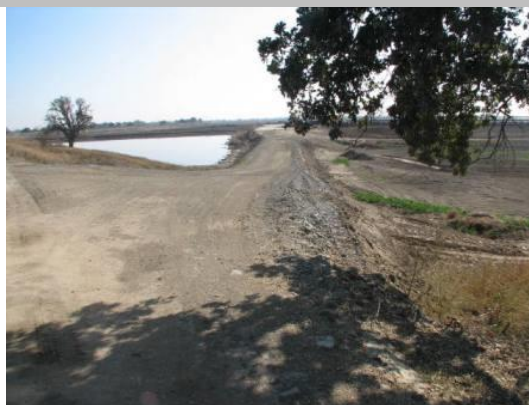
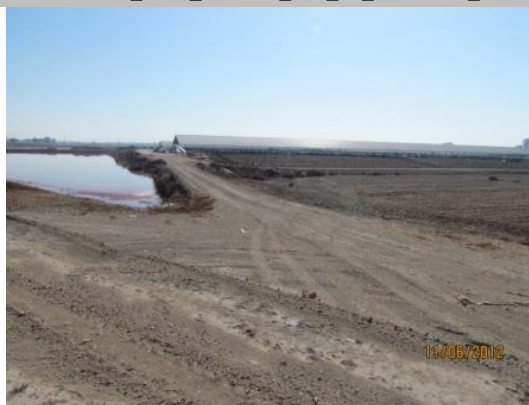
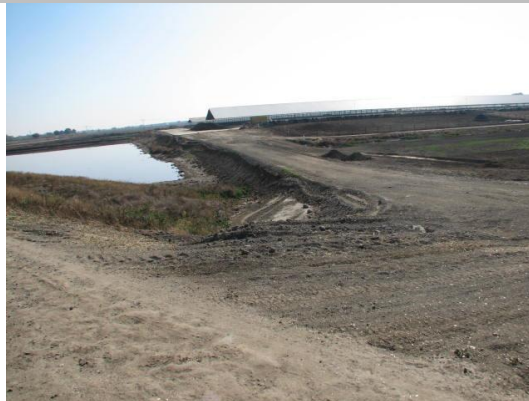
11/08/2011 New ramp has been constructed by Dairy farmer connecting his barns to the levee.

Completed new ramp constructed by Dairy farmer connecting his barns to the levee.

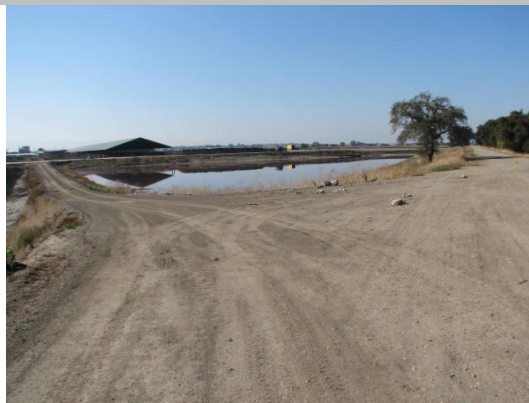
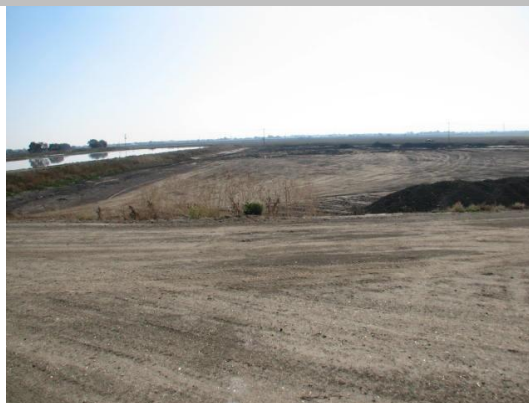
LM Start	5.29	Rating **	U	Issue No.	30
LM End	5.29	Issue Type +	En	Location *	LS
Category	Earthen Levee			GPS Latitude/Longitude	
				Start	End
Item	Encroachments			37.782268 °	37.782268 °
				-121.342257 °	-121.342257 °
DWR ID	DWR_RD2058_01_s_2012_30				
Comment Code					
RA : Ramp					
Inspector Comment					
Ramp constructed to dairy. Raised ramps, see issue 29 are creating new holding ponds for dairy at levee toe.

11/08/2011 Photo shows existing middle ramp to the levee which has been raised.

Completed new ramp constructed by Dairy farmer connecting his barns to the levee.

11/08/2011 Photo shows view from the levee looking to the left of the middle ramp.

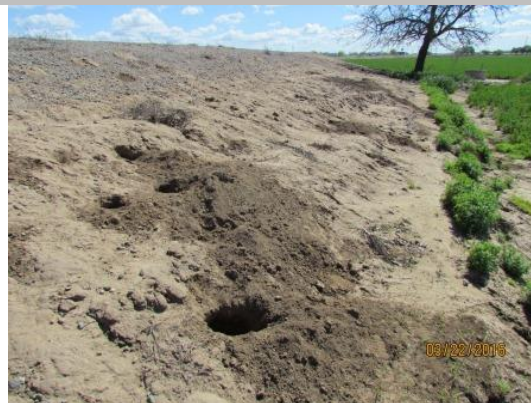
Photo 1 of 1 : SP_2016_RD2058_111_27_20160324_00042.jpg

View of the rodent burrows on the landside levee slope.

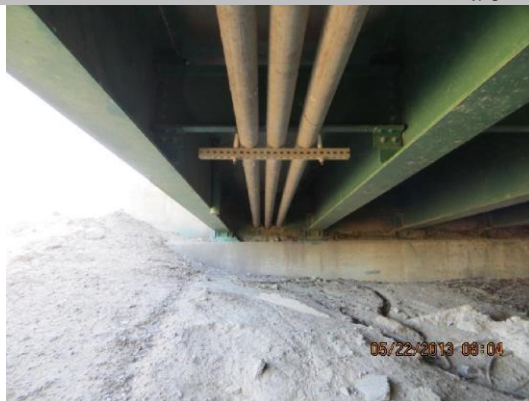
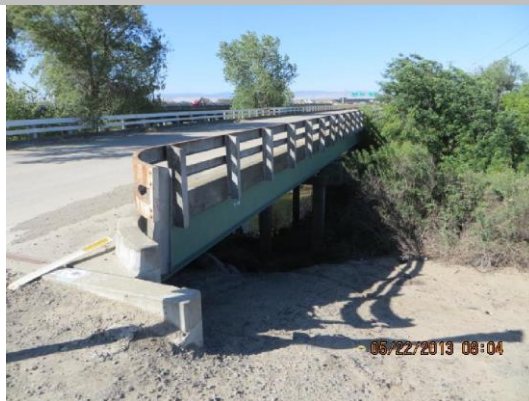
LM Start	6.46	Rating **	M	Issue No.	979
LM End	6.46	Issue Type +	En	Location *	LS
Category	Supplemental			GPS Latitude/Longitude	
				Start	End
Item	DWR UCIP Field Study			37.770158 °	37.770158 °
				-121.329430 °	-121.329430 °
DWR ID					
Comment Code					
Inspector Comment					
FS_ID:45871 DS_ID:22701 EP_NO: 13262 Repair Type: Non-Urgent Crossing Status: Indicator Found UCIP Comments: Owner needs to install signs at crossing. FIELD_STRUCT_DESC: Three 4-inch communication conduits encased in concrete through levee 3.0 feet below crown (Permit No. 13262, 1981). Sign on both banks of levee. Pipes visible under Manthey Rd Bridge at Paradise Cut. FS Date: 5/13/2015

Pipes visible under Manthey Rd Bridge at Paradise Cut.

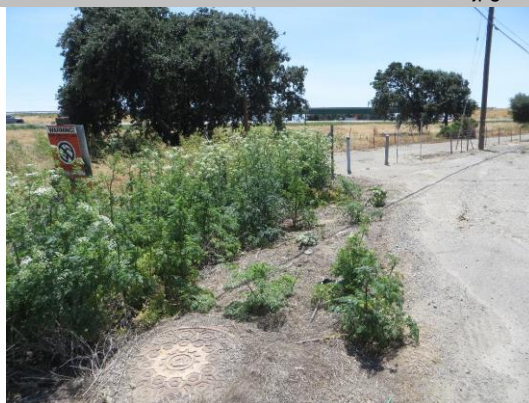
FS_ID:45769
DS_ID:25078
EP_NO: 13262
Repair Type: Non-Urgent
Crossing Status: Indicator Found
UCIP Comments: Owner needs to install sign at crossing.
FIELD_STRUCT_DESC: 3 of 3: 4-inch communication conduit encased in concrete through levee 3.0 feet below crown. Sign on both banks of levee. Manhole on both sides of Mantney Rd at utility crossing. (Permit No. 13262, 1981)
FS Date: 5/13/2015

Cuts in pavement visible apprx. 450 ft from WS toe.

Comm sign and Pac Bell manhole apprx. 600 ft from LS toe.
